**Housing the Workers**

**Early London County Council Housing  
1889-1914**

**34 - Fulham Palace Road**

## Bearcroft Buildings, New Kings Road, 1906

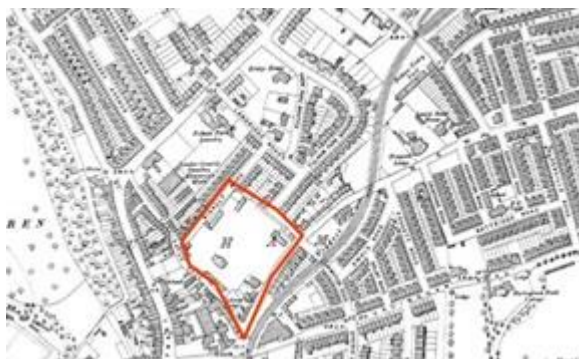
Fig. 3: Original plan for site from 1896 OS map

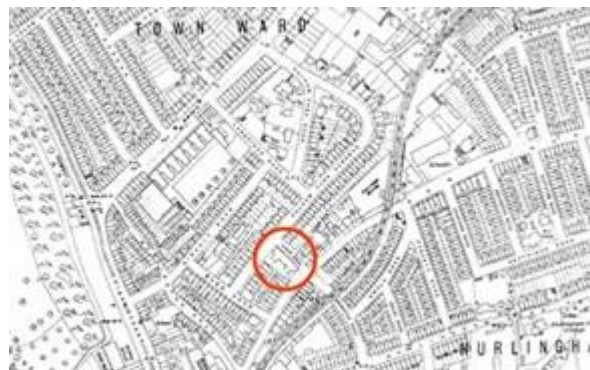
Fig. 4: Site as developed from 1916 OS map with Bearcroft Buildings circled

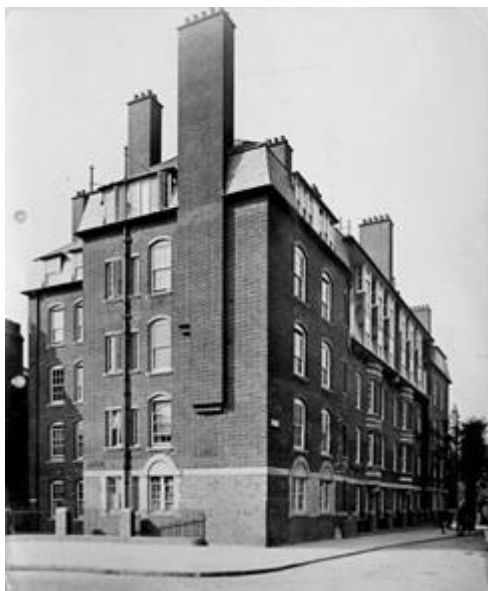
The buildings show little fine architectural detailing apart from very impressive chimney stacks. As with most Council buildings around this time the top storey is in the mansard roof.

Fig. 6: Bearcroft Buildings front view (LMA ref: SC/PHL/02/0766)

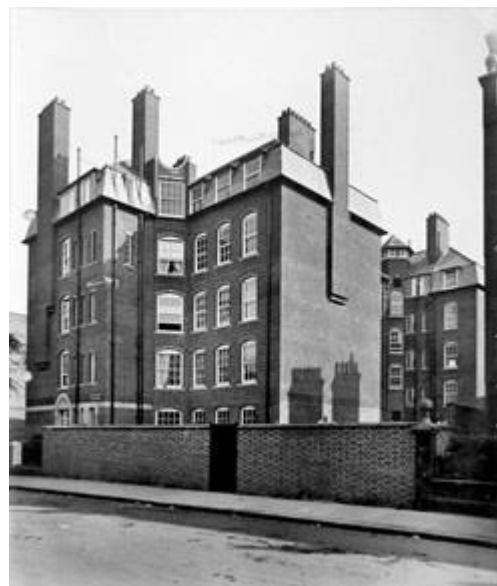
Fig. 7: Bearcroft Buildings rear view (LMA ref: SC/PHL/02/0766)

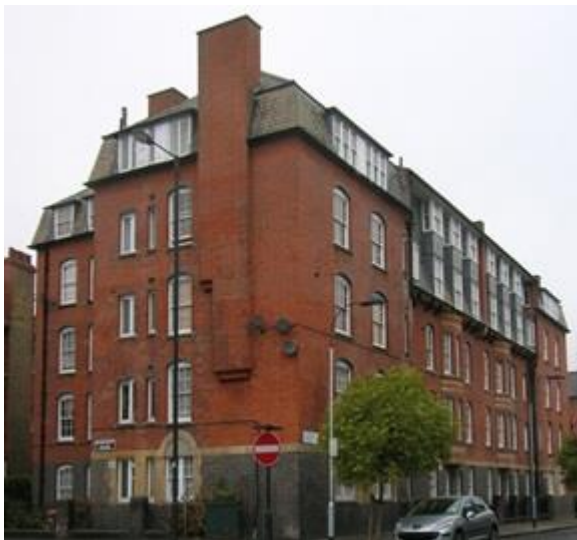
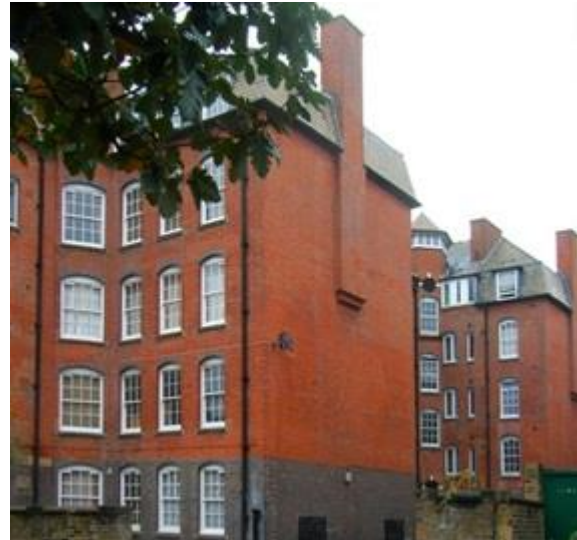
The building stands today. It looks in reasonable condition but the lack of walkways in the original design makes them look a bit oppressive. Reduction in the height of the chimneys has given the buildings a less grand look.

Fig. 8: Bearcroft House 2009

Fig. 9: Bearcroft House 2009
